Harbor House Condominium Project Featuring Sonoguard and SoftSand® Rubber

Private Parking Deck

Sonoguard Waterproofing Membrane Applied In 2000

Summary: Head to Head Aggregate Test

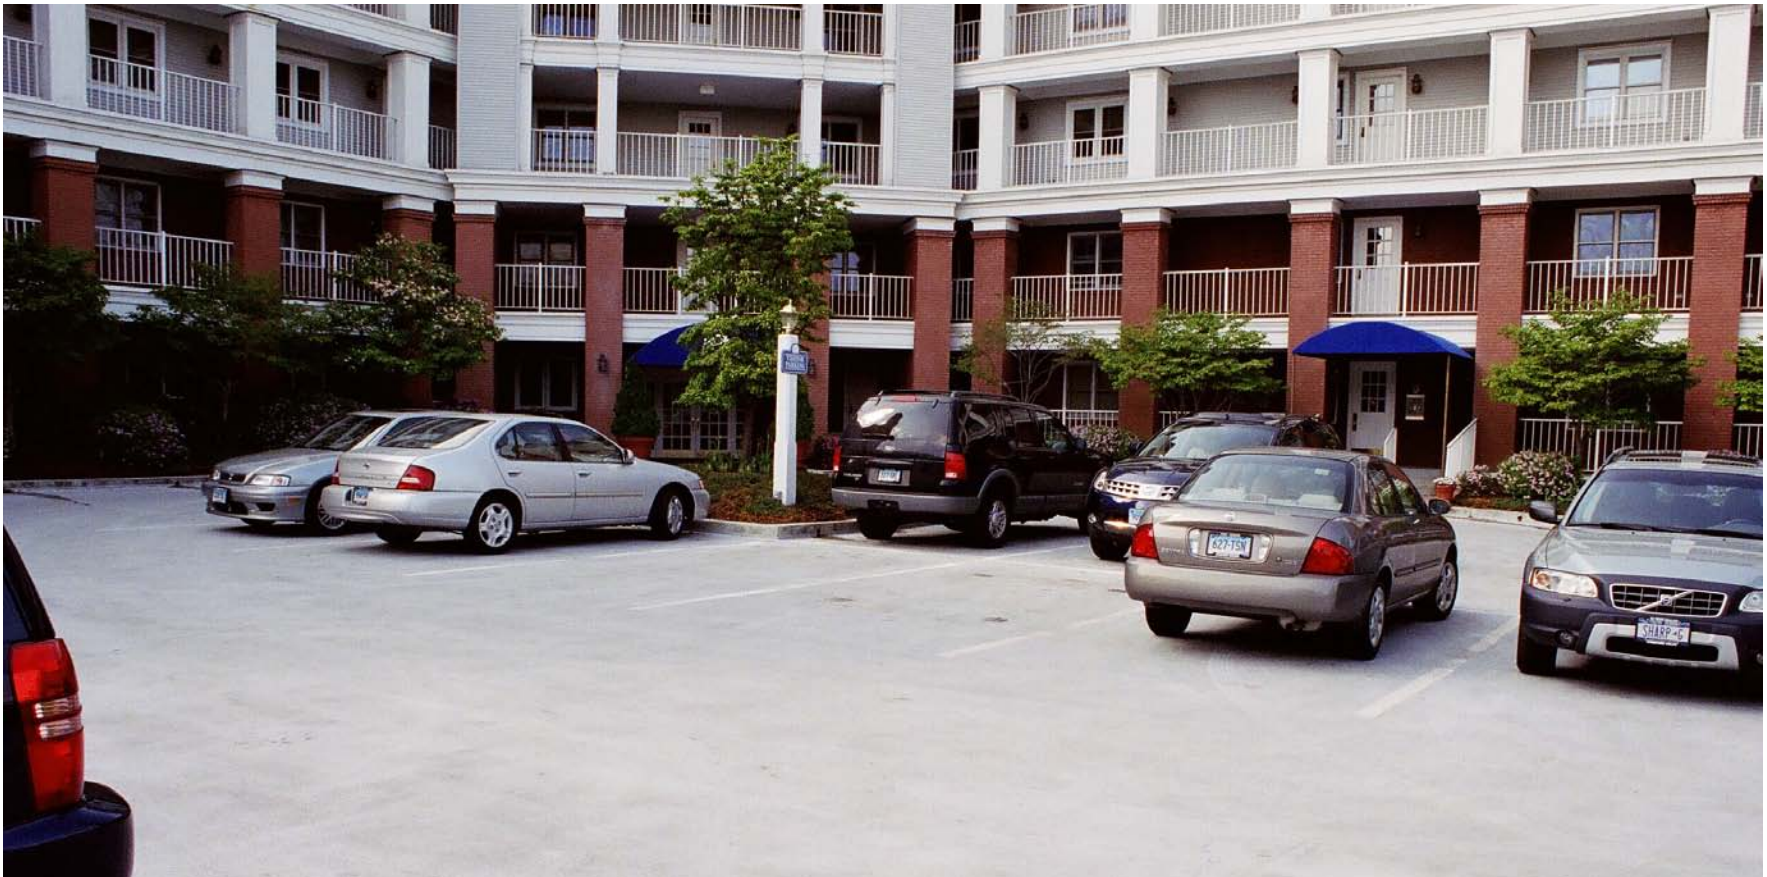
Sonoguard Aggregate **And** SoftSand Rubber Particles Applied

- Sand Added To “Hedge” Risk
- White SoftSand Particles Used As Marker Color

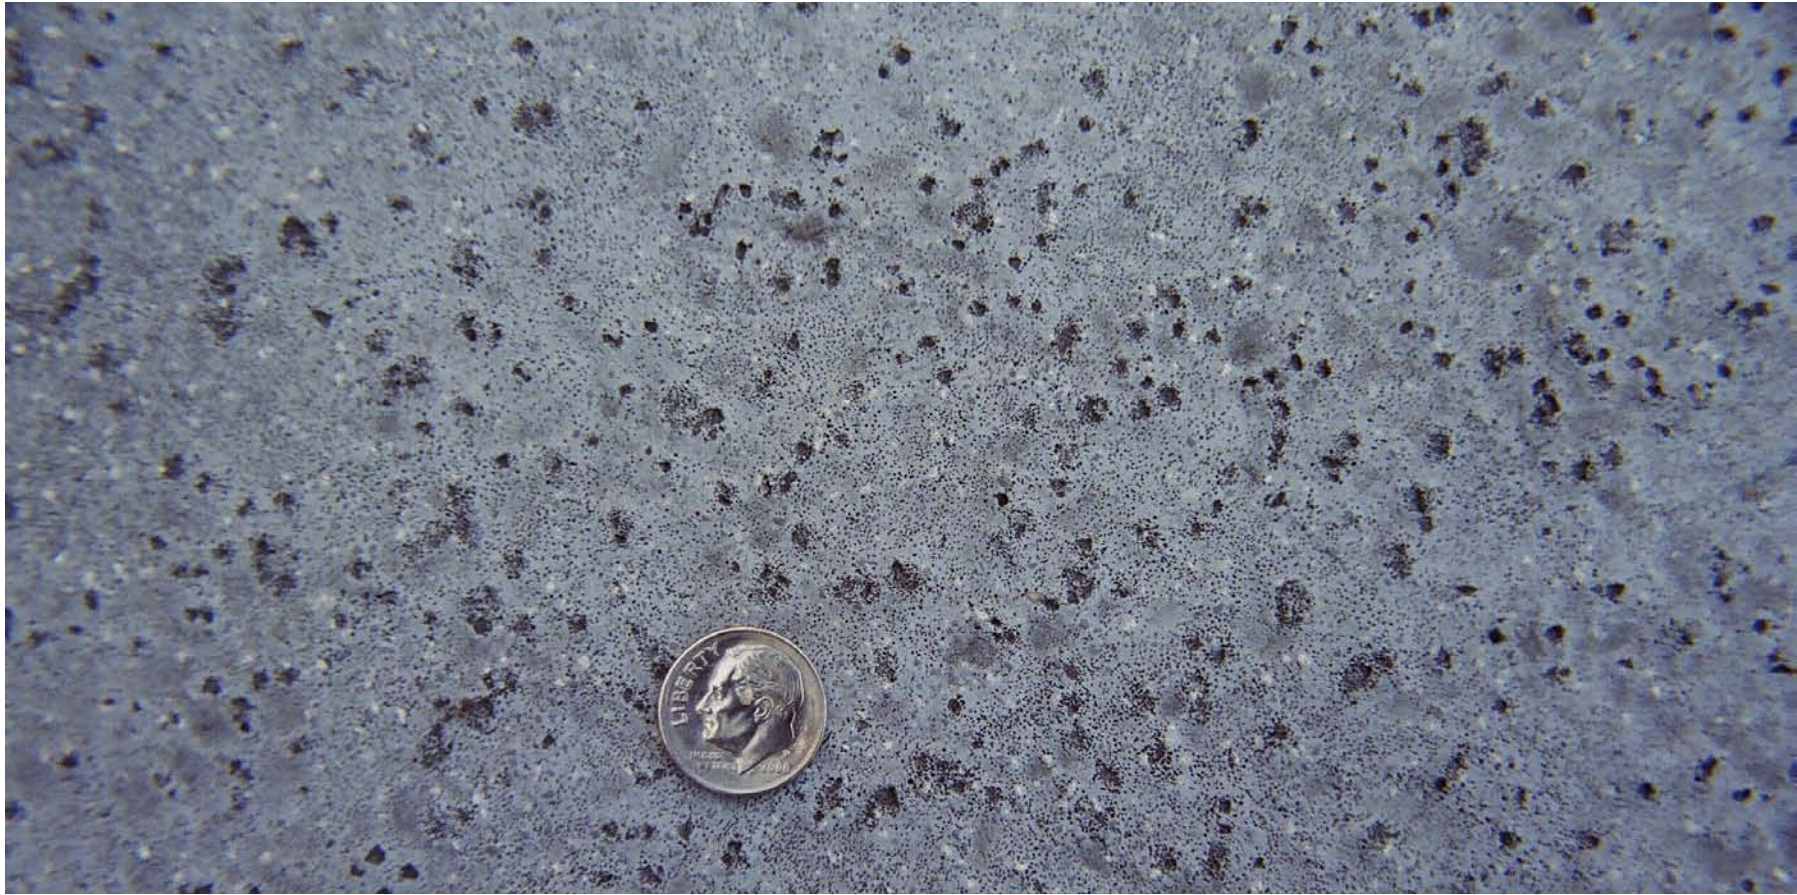
6 Years Later:

- Black Holes Where Sonoguard Aggregate Was Ejected
- Loose Grain of Sonoguard Aggregate Found-See President's Temple
- **White SoftSand Particles Still Clearly Embedded in Gray Top Coat**

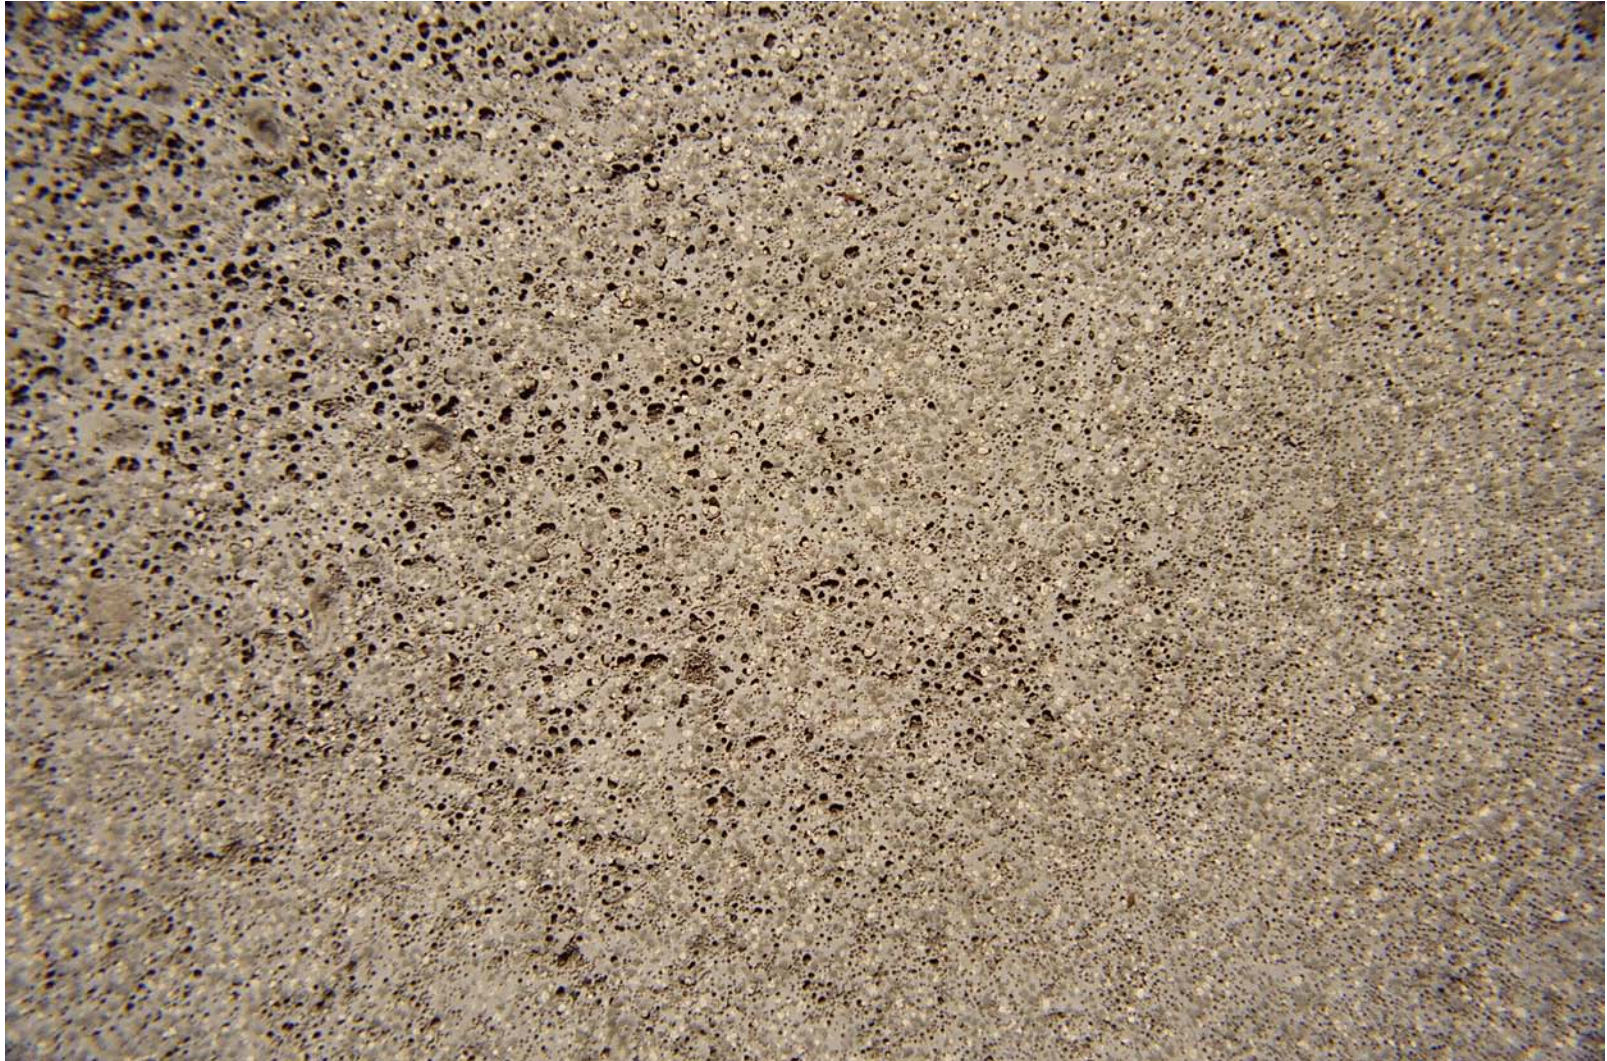
Other Areas Showing Sand Holes (Black) and SoftSand Rubber (White)

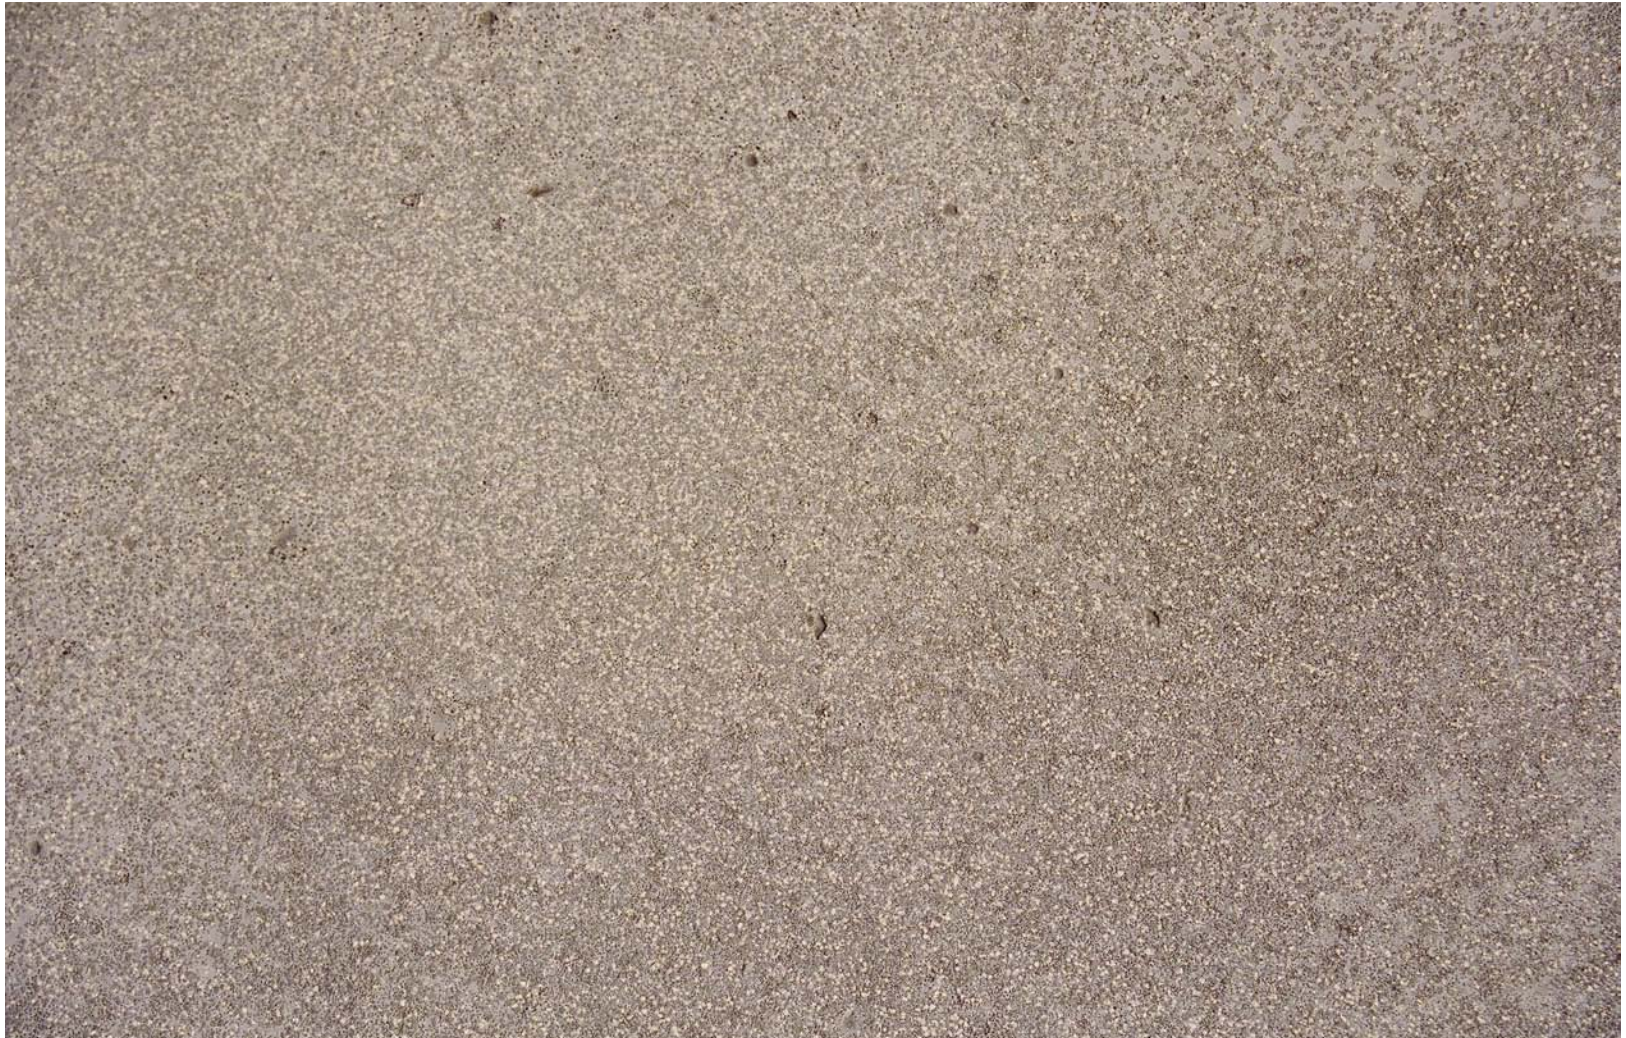
White SoftSand Particles Exposed After Top Coat Wear

- SoftSand Particles Are Still Firmly Embedded After Top Coat Wears Down

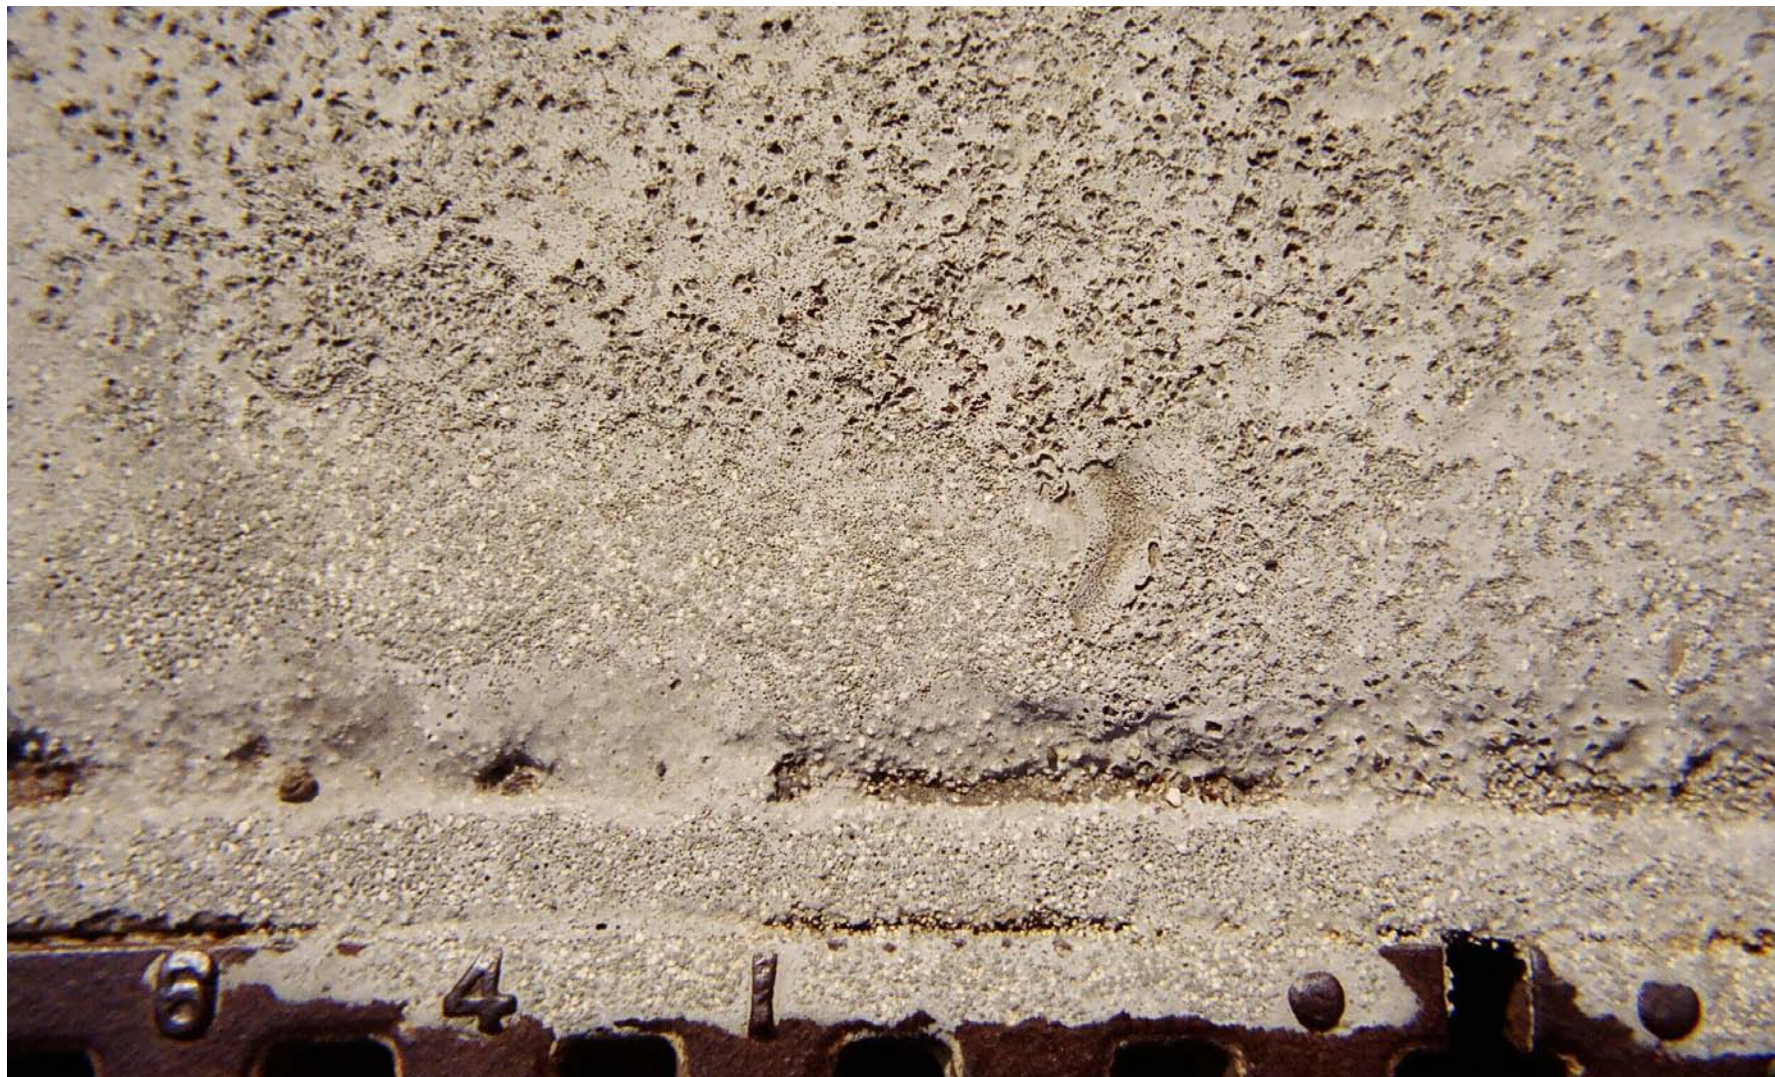
More Evidence of Bond Between Sonoguard and SoftSand Rubber

- Grate Creates Elevation Change And Tire Impact Area
- Sonoguard and White SoftSand Particles Remain Tightly Bonded

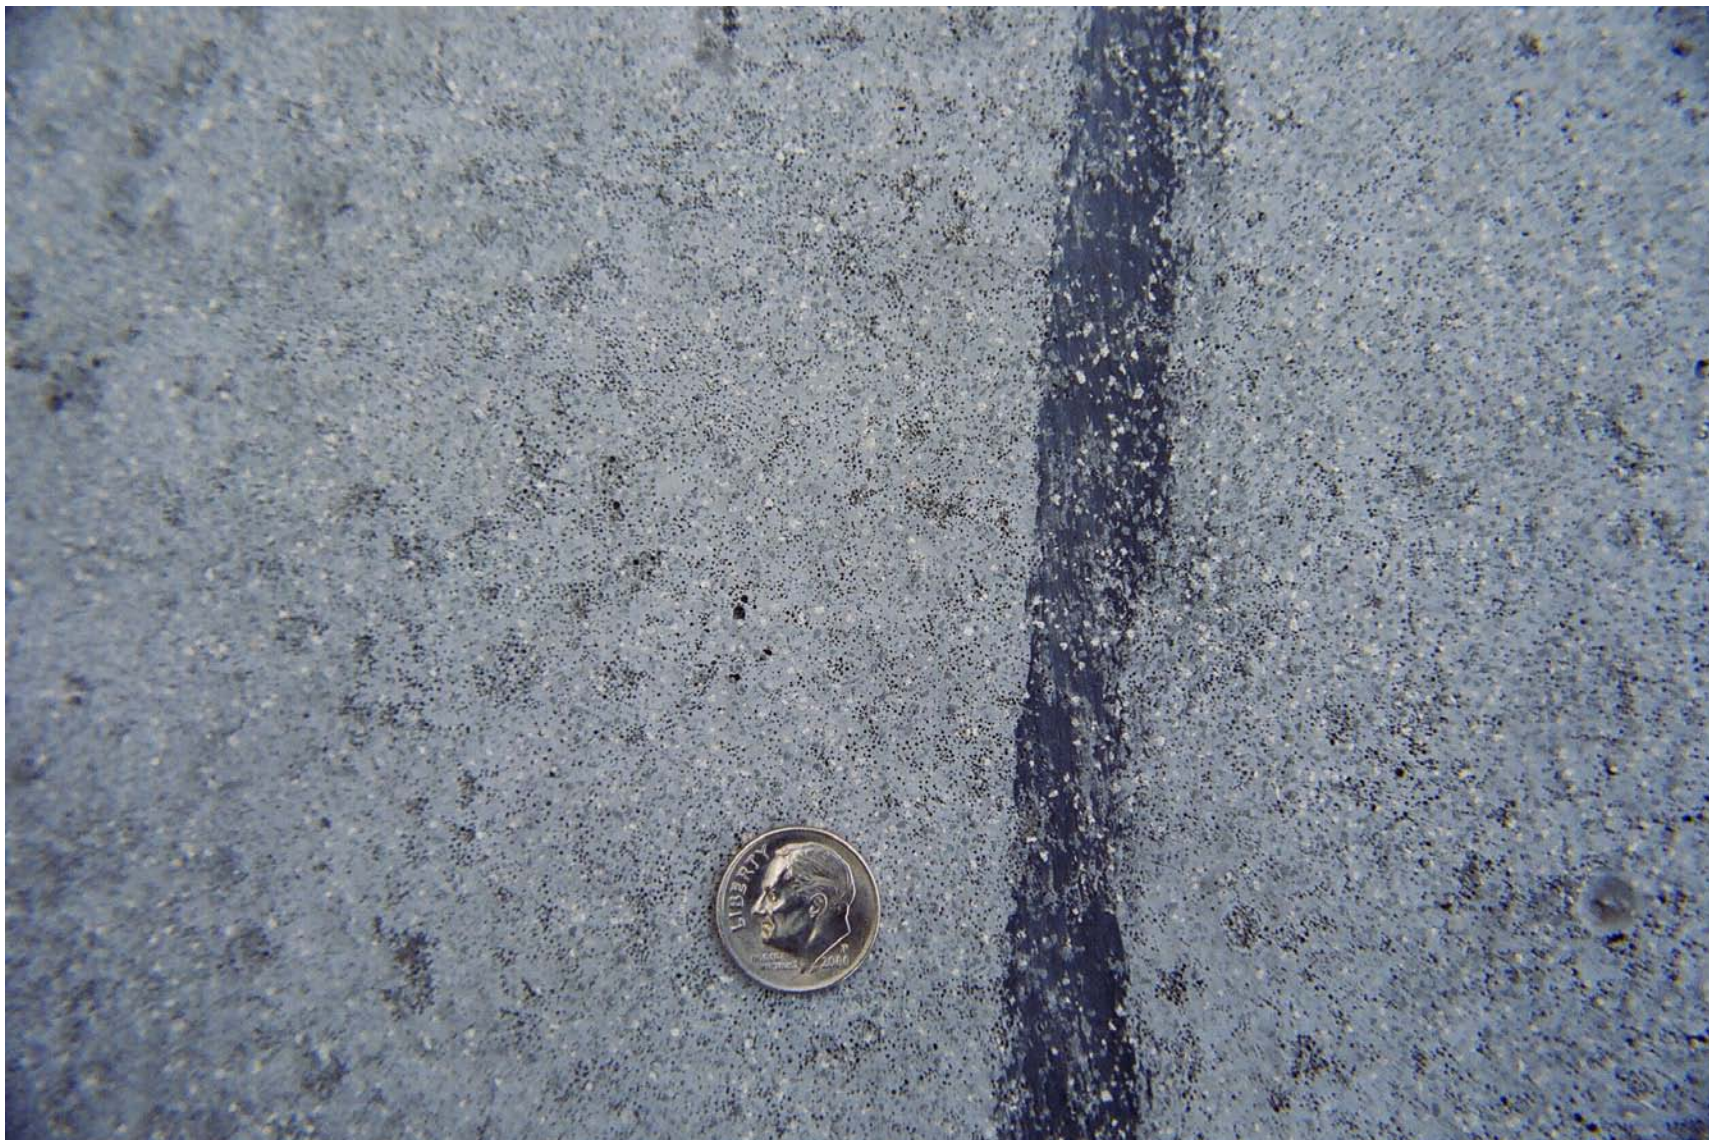
Tire Mark Highlights White SoftSand Particles
